I-75 REST AREAS PROJECT DEVELOPMENT AND ENVIRONMENT (PD&E) STUDY

SARASOTA AND CHARLOTTE COUNTIES

FINAL LEVEL 1 CONTAMINATION SCREENING EVALUATION REPORT (CSER)

FINANCIAL PROJECT NO.: 436602-1-22-01

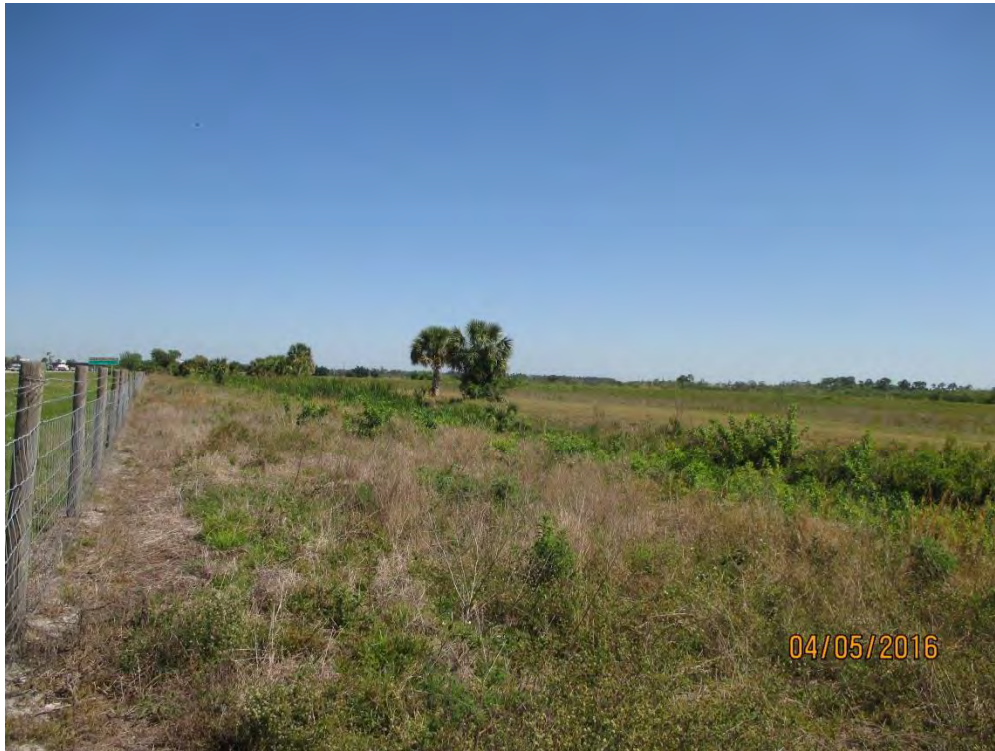
During the site reconnaissance, this Rest Area Alternative was observed as pastureland east of I-75 in Charlotte County, Florida. Offsite, I-75 was apparent abutting west and a man-made pond apparent abutting east. The specific location is depicted in **CSER-Appendix B**. Photographs taken during site reconnaissance are presented in **CSER-Appendix G**.

South end of NB-2 Rest Area Alternative looking northeast

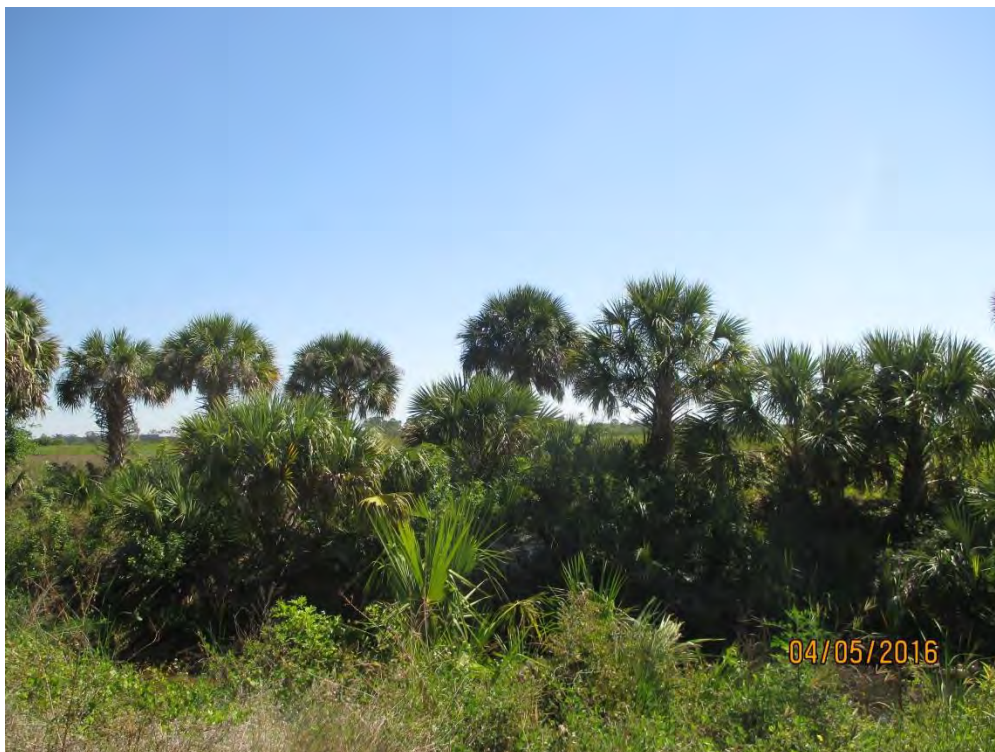
North end of NB -2 Rest Area Alternative looking east

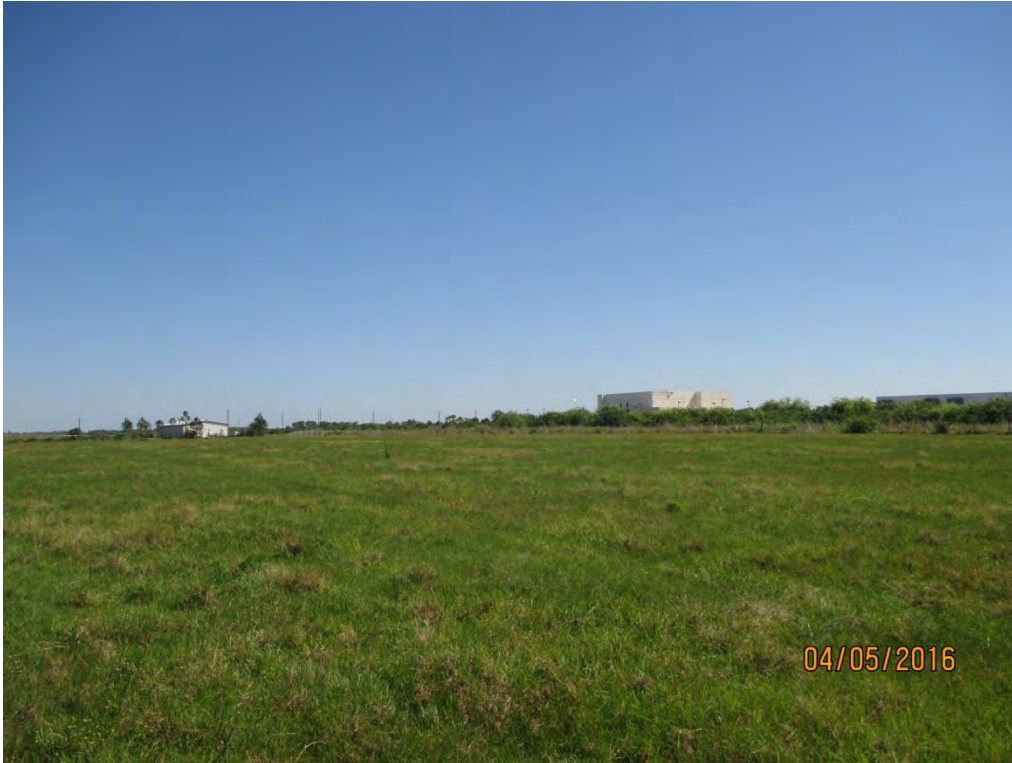
During the site reconnaissance, this Preferred Rest Area Alternative was observed as pastureland east of I-75 located in Charlotte County, Florida. The specific location is depicted in **CSER-Appendix B**. Offsite I-75 was located abutting west, Airport Road to the north, a warehouse-type building followed by the Charlotte County Public Safety and Vehicle Maintenance building to the east, and Cheney Brothers, Inc. (CBI) Building to the south. Photographs taken during site reconnaissance are presented in **CSER-Appendix G**.

South end of NB-2B Preferred Rest Area Alternative looking northeast

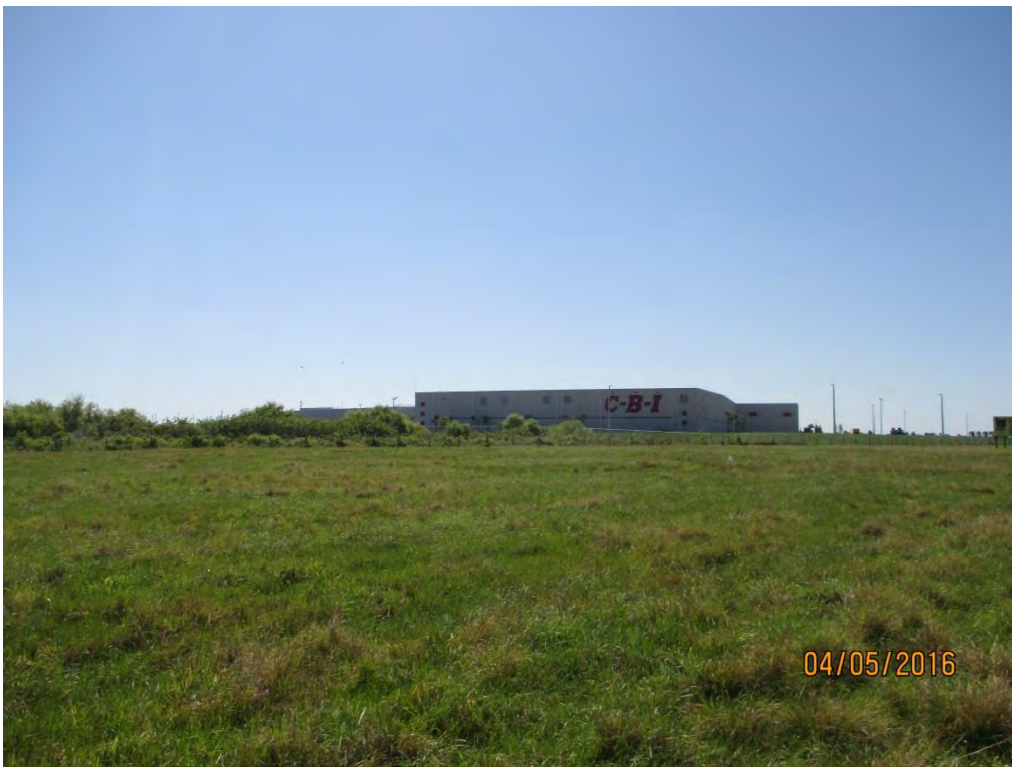
Central area of NB-2B Preferred Rest Area Alternative looking southeast

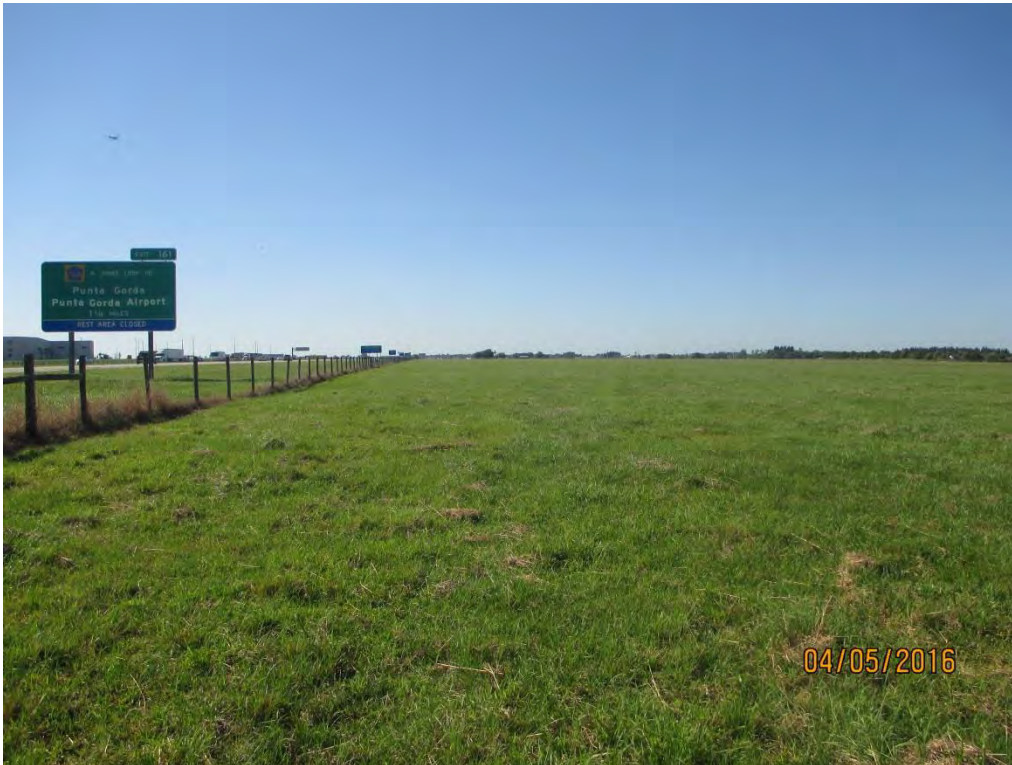
During the site reconnaissance, this Preferred Rest Area Alternative was observed as pastureland in Charlotte County, Florida. The specific location is depicted in **CSER-Appendix B**. Offsite, I-75 was observed abutting east, with pastureland to the north, west, and south. Photographs taken during site reconnaissance are presented in **CSER-Appendix G**.

North end of SB-2 Preferred Rest Area Alternative looking south

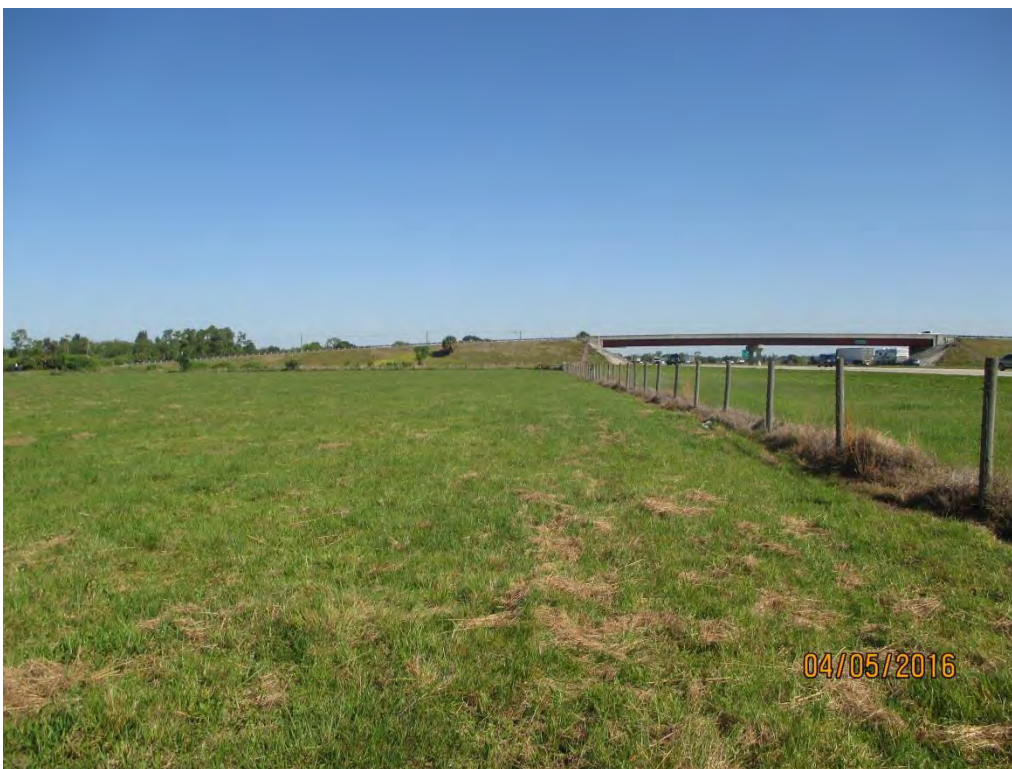
South end of SB-2 Preferred Rest Area Alternative looking north

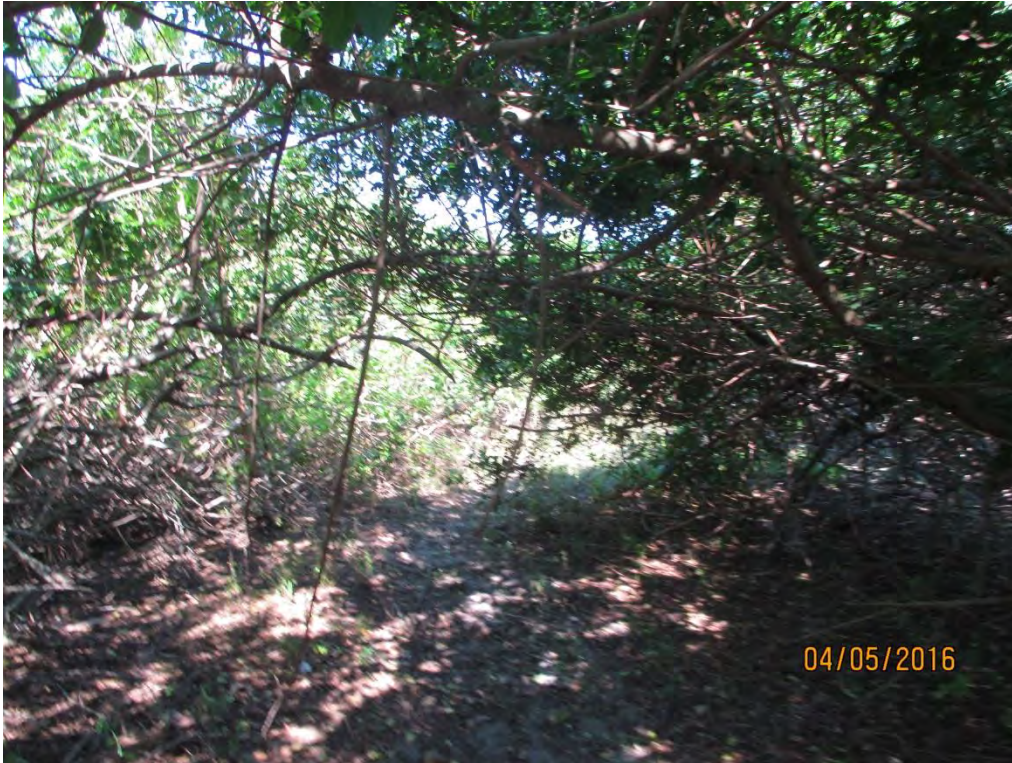
During the site reconnaissance, this Rest Area Alternative was observed as woods and an existing, operational “weigh-in-motion” truck weighing station. An emergency generator with possible fuel source was observed onsite. No other obvious environmental concerns were noted during site reconnaissance. The specific location is depicted in **CSER-Appendix B**. Offsite, woods and man-made ponds were observed to the north and east, with pastureland to the south and I-75 to the west. Photographs taken during site reconnaissance are presented in **CSER-Appendix G**.

South end of SB-WIM Rest Area Alternative looking north

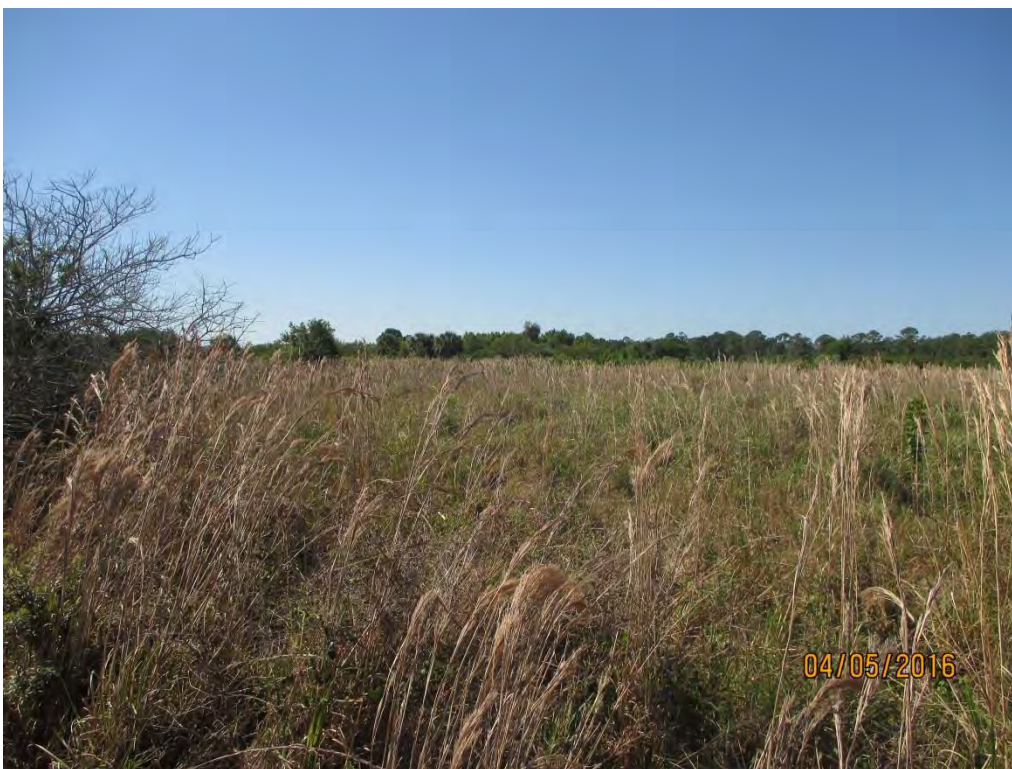
North end of SB-WIM Rest Area Alternative looking southwest

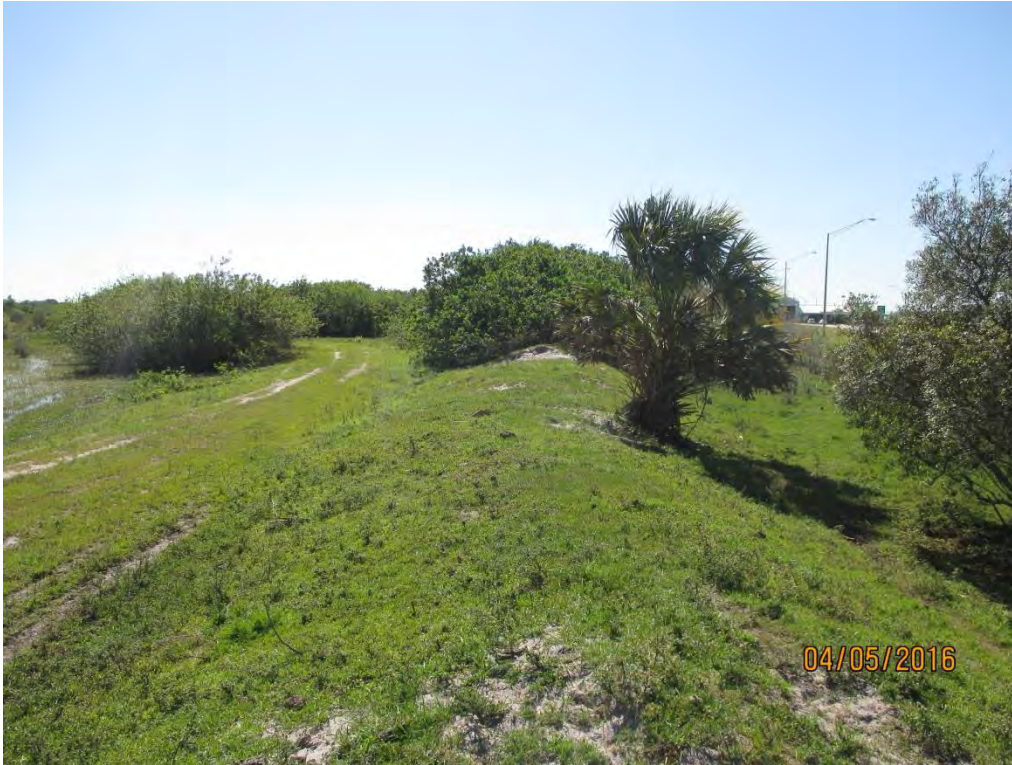
During the site reconnaissance, this Rest Area Alternative was observed as woods and an existing, operational “weigh-in-motion” truck weighing station. An emergency generator with possible fuel source was observed onsite. No other obvious environmental concerns were noted during site reconnaissance. The specific location is depicted in **CSER-Appendix B**. Offsite, man-made ponds were observed to the south and west, a residential neighborhood to the north, and I-75 to the east. Photographs taken during site reconnaissance are presented in **CSER-Appendix G**.

North end of NB-WIM Rest Area Alternative looking southeast

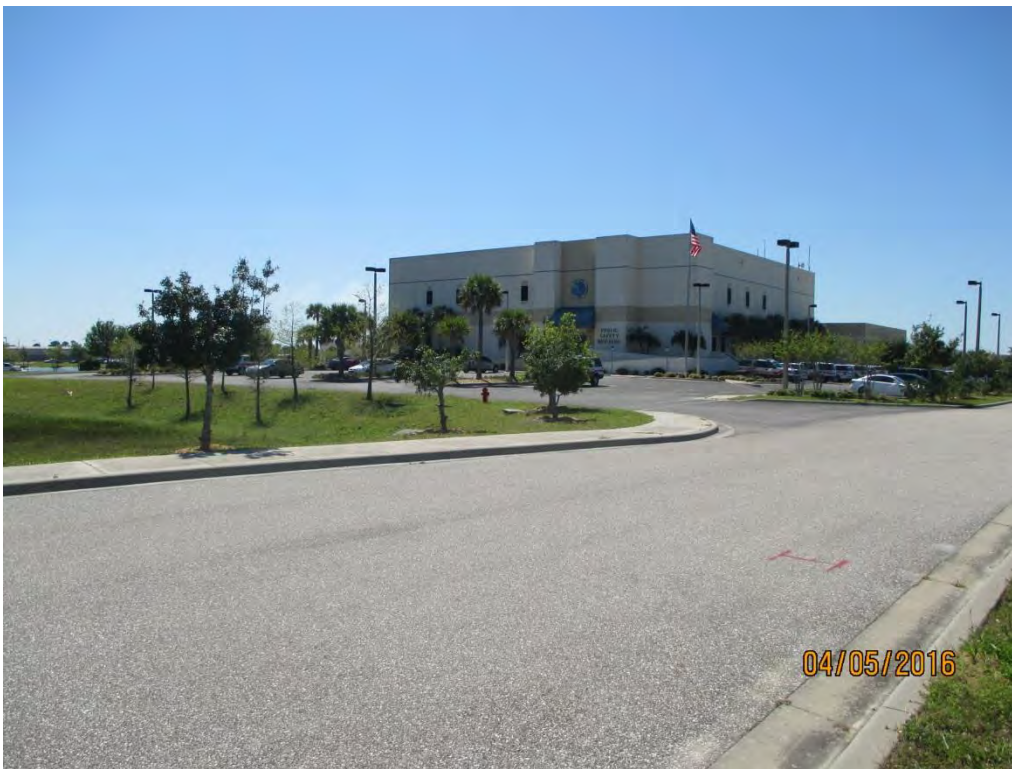
Charlotte County Public Safety Building is located approximately 550 feet east of this Preferred Rest Area Alternative. During the site reconnaissance, this facility was observed as the Charlotte County Public Safety Building. According to the Environmental Data Management, Inc. (EDM) report, one 3,800 gallon double-walled aboveground storage tank (AST) has been in operation at the site since May 2007. The tank stores diesel fuel and is associated with an emergency generator. The tank is located greater than 500 feet east of the nearest Rest Area Alternative (NB-2B). According to the Florida Department of Environmental Protection (FDEP) OCULUS database, this site was included in a compliance enforcement case that involved failure to conduct monthly release detection, failure to provide 30-day and 48-hour notification of installation activities, and failure to provide a release detection response level in writing in accordance with Rule 62-762 of the Florida Administrative Code. The complaint was settled in June 2008 by payment of a civil penalty. The most recent Annual Compliance Site Inspection Report by the FDEP dated 7/29/2014 noted the facility is ‘in compliance.’ No discharges to the soil or groundwater have been reported or confirmed for this facility. No staining or evidence of a discharge was observed during the site visit. Based on the considerable separation distance

Site No. & Name*		Street Address	Type of Concern	Facility ID No.	Distance/Direction to nearest Rest Area Alternative	Site History, Regulatory Status and Comments
1	Charlotte County Public Safety Building	26581 Airport Rd, Punta Gorda	storage tanks	9809452	550 feet east of NB-2B	During the site reconnaissance, this facility was observed as the Charlotte County Public Safety Building. According to the Environmental Data Management, Inc. (EDM) report, one 3,800 gallon double-walled aboveground storage tank (AST) has been in operation at the site since May 2007. The tank stores diesel fuel and is associated with an emergency generator. The tank is located greater than 500 feet east of the nearest Preferred Rest Area Alternative (NB-2B). According to the Florida Department of Environmental Protection (FDEP) OCULUS database, this site was included in a compliance enforcement case that involved failure to conduct monthly release detection, failure to provide 30-day and 48-hour notification of installation activities, and failure to provide a release detection response level in writing in accordance with Rule 62-762 of the Florida Administrative Code. The complaint was settled in June 2008 by payment of a civil penalty. The most recent Annual Compliance Site Inspection Report by the FDEP dated 7/29/2014 noted the facility is 'in compliance.' No discharges to the soil or groundwater have been reported or confirmed for this facility. No staining or evidence of a discharge was observed during the site visit. Based on the considerable separation distance to the nearest Rest Area Alternative (NB-2B) and the lack of evidence of a discharge, this facility is not considered a contamination concern to the project.

View to the southeast from Airport Road of Charlotte County Public Safety Building

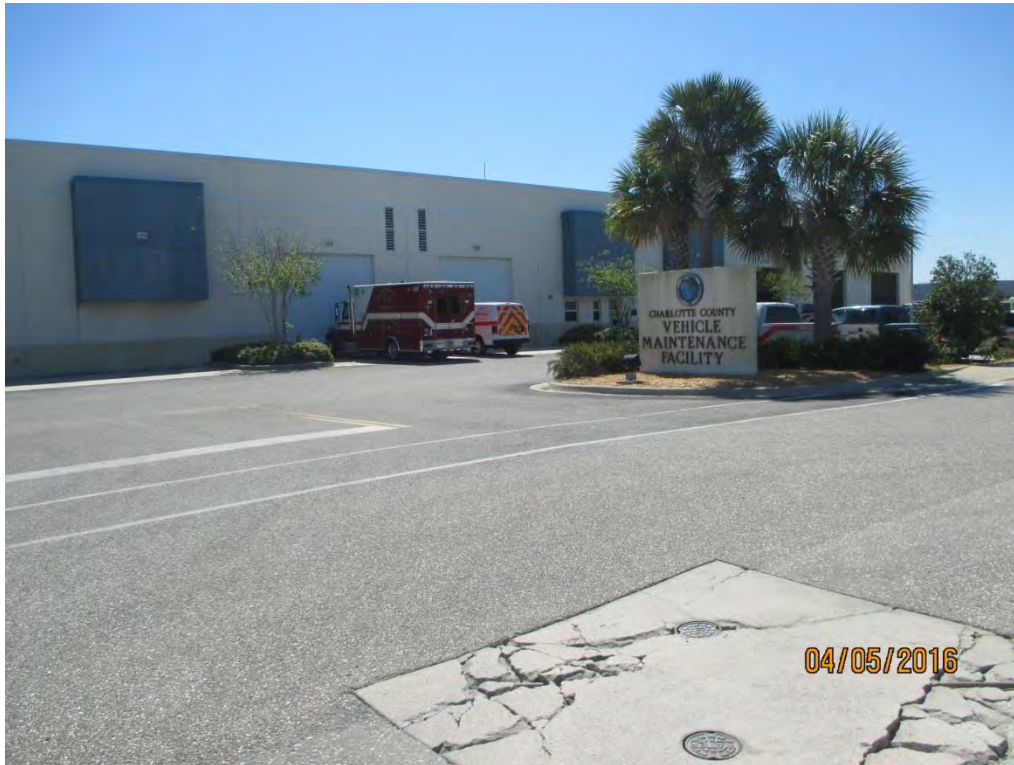
Charlotte County Vehicle Maintenance Building is located approximately 500 feet east of this Preferred Rest Area Alternative. During the site reconnaissance, this facility was observed as the Charlotte County Vehicle Maintenance Building. According to the EDM report, one 5,000 gallon double-walled AST has been in operation at this site since June 2007. The tank stores diesel fuel and is associated with an emergency generator. The tank is located greater than 500 feet east of the nearest Preferred Rest Area Alternative (NB-2B). According to the FDEP OCULUS database, this site was included in a compliance enforcement case that involved failure to conduct monthly release detection, failure to provide 48-hour notification of installation activities, and failure to provide a release detection response level in writing in accordance with Rule 62-762 of the Florida Administrative Code. The complaint was settled in June 2008 by payment of a civil penalty. The most recent Annual Compliance Site Inspection Report by the FDEP dated 7/15/2015 noted the facility is ‘in compliance.’ No discharges to the soil or groundwater have been reported or confirmed for this facility. No staining or evidence of a discharge was observed during the site visit. Based on the considerable separation distance to NB-2B Preferred Rest Area Alternative and the lack of evidence of a discharge, this facility is not considered a contamination concern to NB-2B Preferred Rest Area Alternative.

2	Charlotte County Vehicle Maintenance	26571 Airport Rd, Punta Gorda	storage tanks	9809450	500 feet east of NB-2B	During the site reconnaissance, this facility was observed as the Charlotte County Vehicle Maintenance Building. According to the EDM report, one 5,000 gallon double-walled AST has been in operation at this site since June 2007. The tank stores diesel fuel and is associated with an emergency generator. The tank is located greater than 500 feet east of the nearest Preferred Rest Area Alternative (NB-2B). According to the FDEP OCULUS database, this site was included in a compliance enforcement case that involved failure to conduct monthly release detection, failure to provide 48-hour notification of installation activities, and failure to provide a release detection response level in writing in accordance with Rule 62-762 of the Florida Administrative Code. The complaint was settled in June 2008 by payment of a civil penalty. The most recent Annual Compliance Site Inspection Report by the FDEP dated 7/15/2015 noted the facility is 'in compliance.' No discharges to the soil or groundwater have been reported or confirmed for this facility. No staining or evidence of a discharge was observed during the site visit. Based on the considerable separation distance to the nearest Rest Area Alternative (NB-2B) and the lack of evidence of a discharge, this facility is not considered a contamination concern to the project.

View to the southeast of Charlotte County Vehicle Maintenance Facility

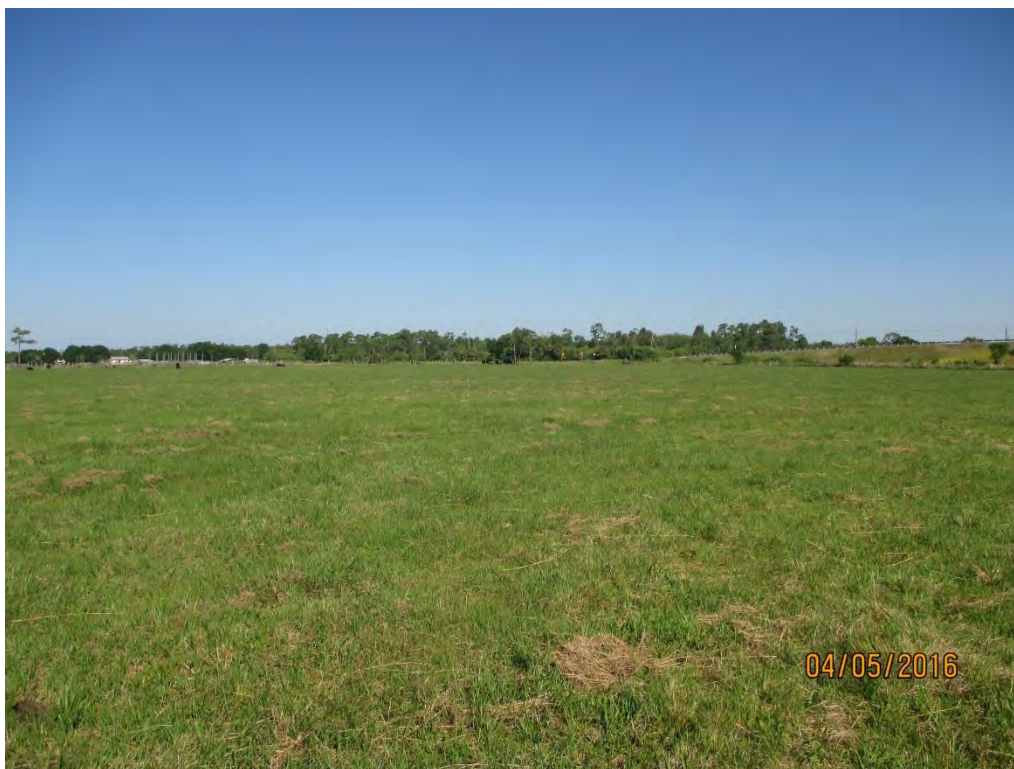
During the site reconnaissance, this facility was observed as open pasture land that included 3 contiguous ponds. According to information reviewed on the FDEP OCULUS database, an inspection of the site was completed in December 1989 in response to a complaint. The complaint involved alleged unpermitted disposal of solid waste to land and water (land clearing debris and residential waste). The property owner stated that the debris was staged in the area so that it could be burned in the future. The FDEP confirmed that the owner held a burn permit and the case was closed in May 1991. No discharges to the soil or groundwater have been reported or confirmed for this facility. This facility was included in the EDM regulatory database report, even though the alleged disposal area was located 1,800 feet from the closest Rest Area Alternative (SB-2). Based on the considerable separation distance to SB-2 (1,800 feet) and the lack of evidence of a discharge, this facility is not considered a contamination concern to SB-2 Preferred Rest Area Alternative.

3	McQueen Farm	SW corner of Airport Rd and I-75, Punta Gorda	solid waste	101002	1,800 feet west of SB-2	During the site reconnaissance, this facility was observed as open pasture land that included 3 contiguous ponds. According to information reviewed on the FDEP OCULUS database, an inspection of the site was completed in December 1989 in response to a complaint. The complaint involved unpermitted disposal of solid waste to land and water (land clearing debris and residential waste). The property owner stated that the debris was staged in the area so that it could be burned in the future. The FDEP confirmed that the owner held a burn permit and the case was closed in May 1991. No discharges to the soil or groundwater have been reported or confirmed for this facility. It is believed that the EDM report has plotted the general location of the McQueen Farm, which was included within the 1/8 mile screening buffer. The location of the inspection area is believed to be 1,800 feet west of the closest Preferred Rest Area Alternative (SB-2). Based on the considerable separation distance to the nearest Rest Area Alternative (SB-2) and the lack of evidence of a discharge, this facility is not considered a contamination concern to the project.

View to the north from near I-75 southbound of location of McQueen Farm

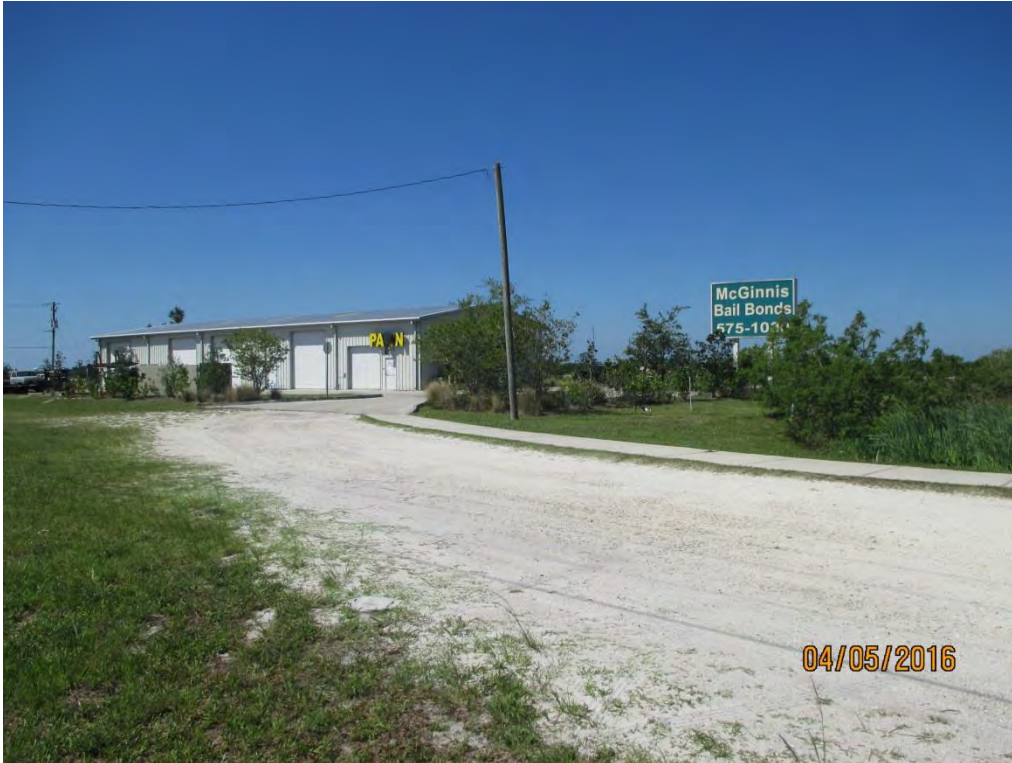
Millwood Manufacturing Building is located 175 feet east of this Rest Area Alternative. During the site reconnaissance, this facility was observed as an approximate 6,000 square foot warehouse-type building. Tenants at the time of our site visit included McGinnis Bail Bonds and a pawn shop. According to information reviewed on the FDEP OCULUS database, Millwood Manufacturing applied for a hazardous waste identification number in August 1997. The application was necessary due to the use of solvents, which are a “listed” and “characteristic” hazardous waste. Millwood Manufacturing was not observed to be in operation during our site reconnaissance, no annual compliance inspection reports were found in the FDEP OCULUS database, and no reports of a discharge were filed. Based on the lack of evidence of a discharge, this facility is not considered a contamination concern to NB-2B Preferred Rest Area Alternative.

4	Millwood Manufacturing	26409 Airport Rd, Punta Gorda	RCRA site	FLR 000033522	175 feet northeast of NB-2B	During the site reconnaissance, this facility was observed as an approximate 6,000 square foot warehouse-type building approximately 175 feet northeast of Rest Area Alternative NB-2B. Tenants at the time of our site visit included McGinnis Bail Bonds and a pawn shop. According to information reviewed on the FDEP OCULUS database, Millwood Manufacturing applied for a hazardous waste identification number in August 1997. The application was necessary due to the use of solvents, which are a "listed" and "characteristic" hazardous waste. Millwood Manufacturing was not observed to be in operation during our site reconnaissance, no annual compliance inspection reports were found in the FDEP OCULUS database, and no reports of a discharge were filed. Based on the lack of evidence of a discharge, this facility is not considered a contamination concern to the project.

View to the southwest from Airport Road of Millwood Manufacturing

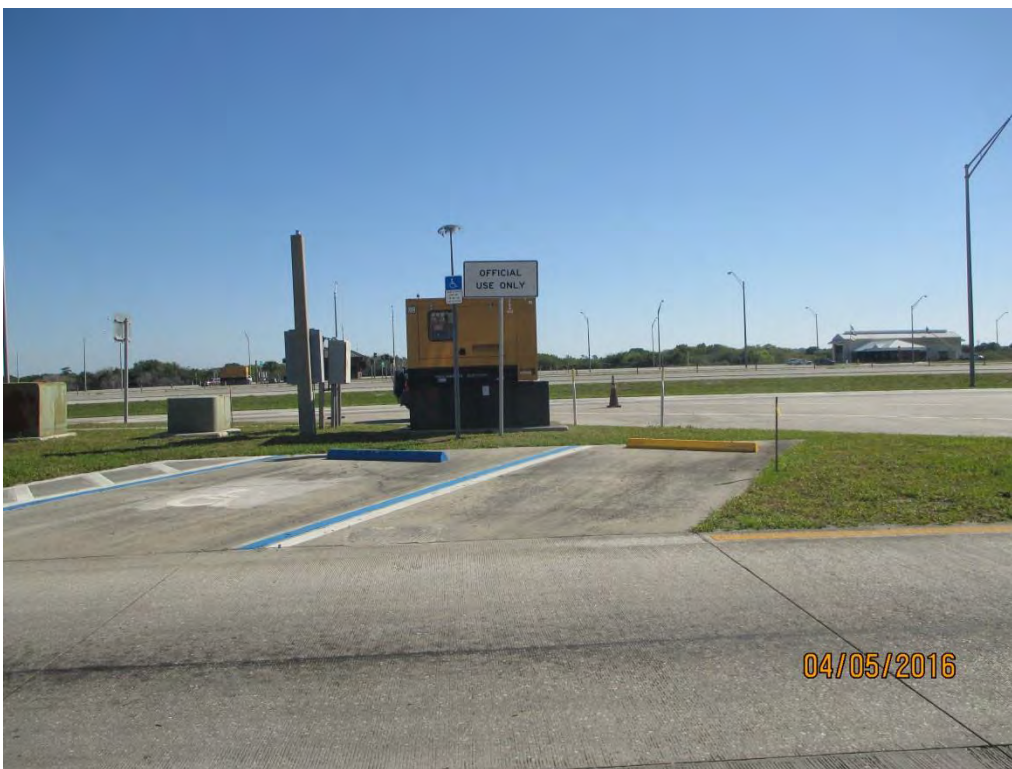
Site No. & Name*		Street Address	Type of Concern	Facility ID No.	Distance/Direction to nearest Rest Area Alternative	Site History, Regulatory Status and Comments
5	Southbound Weigh-In-Motion Station	Southbound I-75, south of South Jones Loop Road	storage tanks	NA	Adjacent east of SB-WIM	During the site reconnaissance, this facility was observed as a truck weighing station. Semi-trucks were observed entering and exiting throughout the time of our site reconnaissance. Two separate structures were observed onsite, an office building located on the central portion and a larger warehouse-type structure presumably used for storage and daily operations located on the northern portion. An approximately 300-gallon water tank was observed on the southwest portion of the property. Grassy drainage areas were observed onsite as well. One emergency generator with a fuel storage tank was observed on the northeast portion of the property. No discharges or staining associated with this emergency generator was observed. Due to the size of the fuel storage tank (less than 550-gallons) this tank was not listed in the EDM regulatory report or MapDirect database. Based on the lack of evidence of a discharge, this facility is not considered a contamination concern to the project.

View to the east of emergency generator located adjacent to SB-WIM
